## LAND USE IN THE AREAS AFFECTED BY GLIMEE-TYPE LANDSLIDES IN THE TRANSYLVANIAN PLAIN. CASE STUDIES: THE LANDSLIDES FROM APATIU, ARCHIUD, BOZIEȘ AND MĂLUȚ

**ABSTRACT.** – **Land Use in the Areas Affected by Glimee-Type Landslides in the Transylvanian Plain. Case Studies: The Landslides from Apatiu, Archiud, Bozieș and Măluț.** A special way of land utilisation in the Transylvanian Plain can be found in areas with glimee-type landslides. Their micro-relief drove people to resort to most various land use methods. From the numerous sites with glimee-type landslides in the Transylvanian Plain, this study focuses on the landslides from Apatiu, Archiud and Măluț. Pastures, hay meadows, orchards and vineyards are among the best represented categories of land use. Knowing the precise area occupied by these categories may offer a valuable insight about the economic importance of these plots of land. Furthermore, we have to stress that recently more and more glimee-type landslides have been included in Natura 2000 protected areas. Such actions help justify the increased attention that must be offered to these areas, economically, scientifically, but also as a tourist attraction.

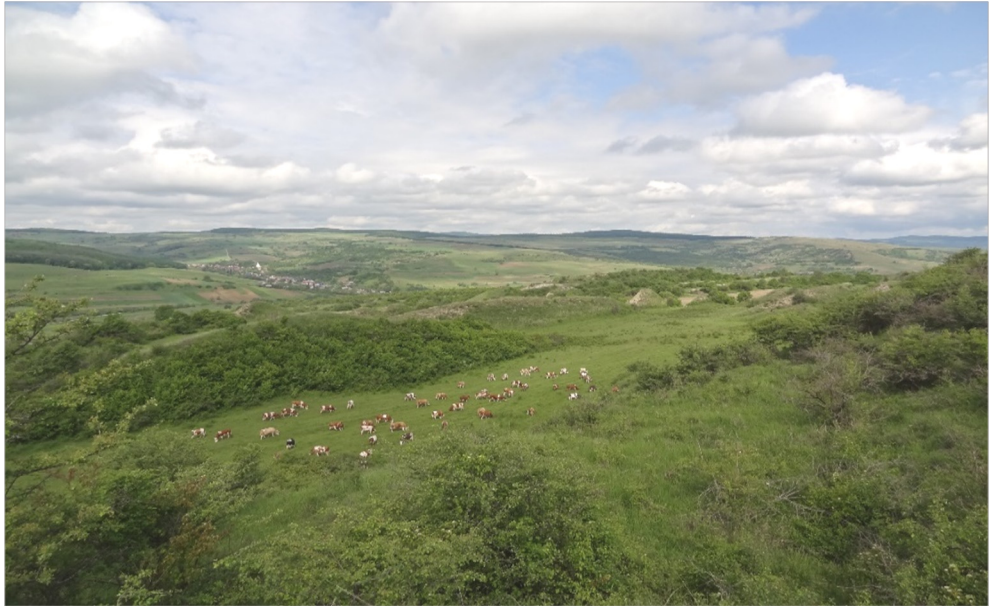
**Fig. 1.** Land cover differences due to slope orientation

slope aspects, with shaded hillsides frequently carrying common hawthorn (*Crataegus monogyna*), common dogwood (*Cornus sanguinea*), cornel cherry (*Cornus mas*), hazel (*Coryllus avellana*), hornbeam (*Carpinus betulus*), and even oak (*Quercus robur*), while sunnier slopes are more xerophilous in nature and are usually covered with *Andropogon ischaemum* (fig. 1).

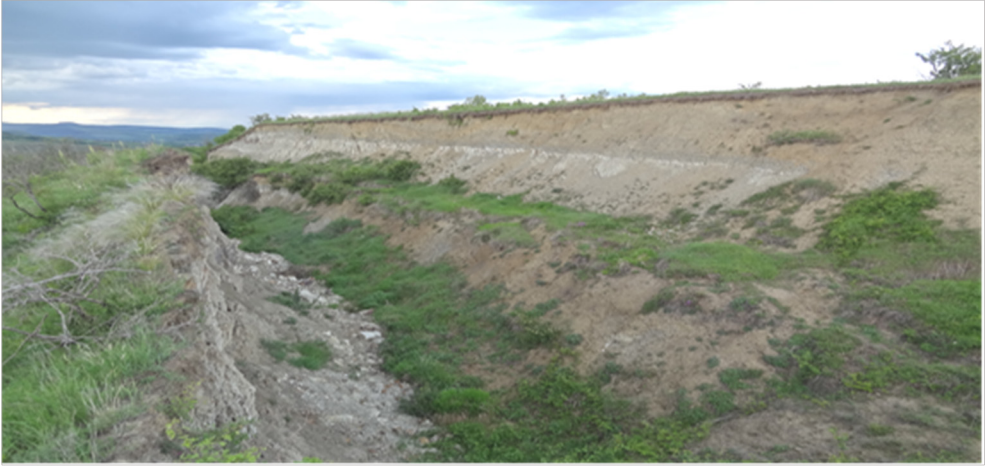
**Fig. 3.** The newly formed depression alignment

These new landslides are in their incipient phase and are much smaller, given present-day climatic conditions. The **glimee ridges complex** lies at the bottom of the slump zone, forming five parallel rows that started to fall apart even during the slide. The ridges have various sizes and are separated by micro-depressions, some of which are larger, while others are not so visible. The largest ridges are those from the 2<sup>nd</sup> and 3<sup>rd</sup> rows, showing relative heights of about 20-25 m. Presently, the first row is affected by a strong re-fragmentation (fig. 3), resulting in a new landslide mass of the same length separated from the originating body by a 3-4 m deep trench, indicating a new depression alignment (fig. 3) (see also Pop, 2015).

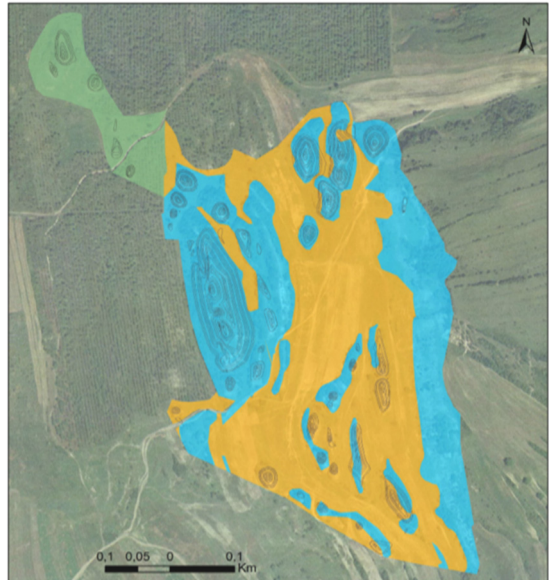
**Fig. 4.** Land use within the site with glimee-type landslides from Apatiu, according to APIA data, 2015 (green: permanent crops, others than vineyards, orchards, etc.; blue: non-productive land, covered with reed and bulrush, or marsh vegetation; orange: permanent pastures)

Regarding the land use of the site, there is an important agricultural reclamation, with permanent pastures still prevailing (fig. 4). The spatial distribution of these pastures is effected by the great extent of transversal depressions and of humid areas in horizontal areas. The prevalence of permanent pastures to the detriment of arable land can be explained simply by the fact that it is not feasible to cultivate small, mostly low-productive parcels. Another explanation could be the distance to the village.

Due to relatively high altitude differences between the transversal depressions and the conical forms with steep slopes, ridges and scarps, these terrains are considered to be non-productive (fig. 4). It must be mentioned that the current land use mode

within this landslide site is implemented according to the annual inventory of the Agricultural Payment and Intervention Agency (APIA), in this case for the year 2015.

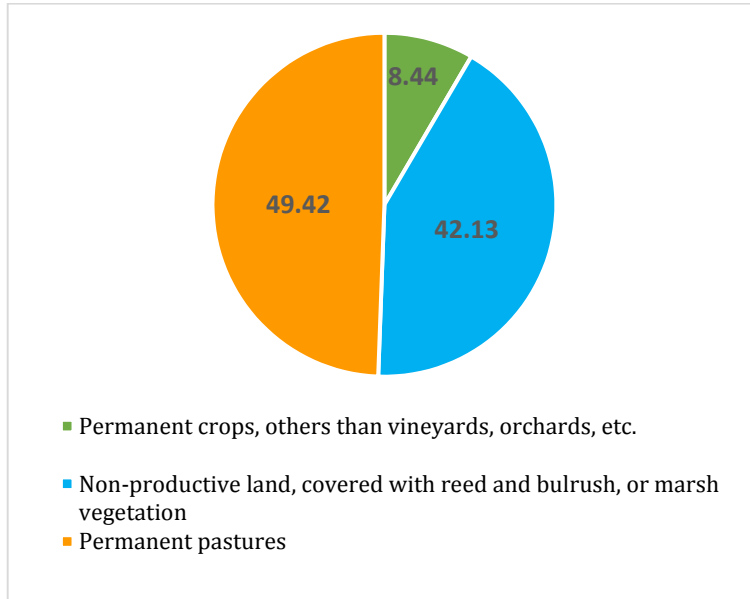
**Fig. 5.** Agricultural reclamation rate and land use of the glimee-type landslide from Apatiu

The agricultural reclamation rate in the landslide site is shown in figure 5. From a total of approximately 42 hectares, 42.13% is non-productive land, 49.42% are permanent pastures, and a small part – 8.44% – is cultivated. This distribution is due to a relatively large number of ridges with a high drop toward the depressions and steep slopes.

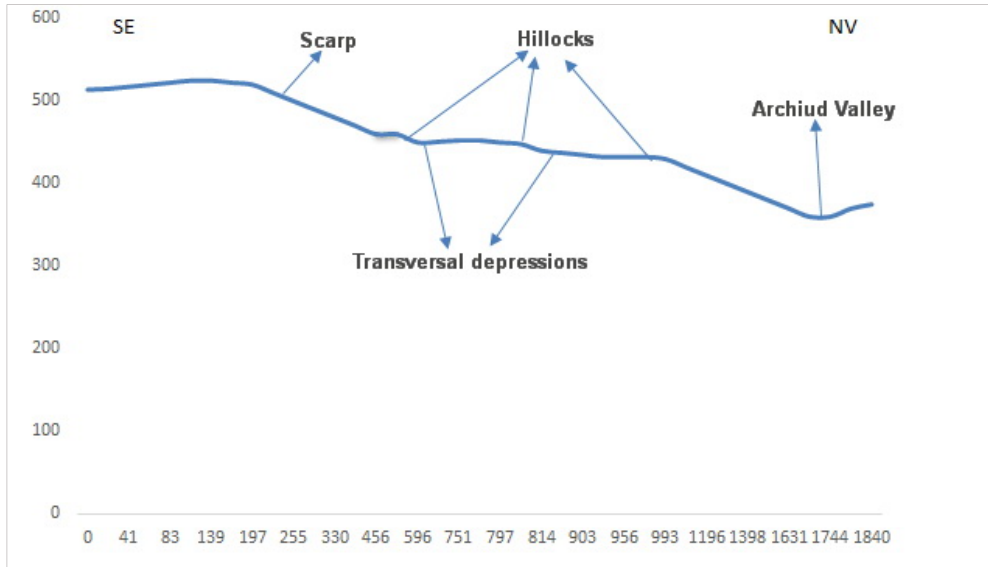
**Fig. 6.** Profile of the landslide from Archiud

The landslide comprises a forested fault scarp of 1.7 km in length, three hillock alignments parallel to the scarp, and very visible transversal depressions (fig. 6). The total area affected by landslides covers over 98.5 hectares.

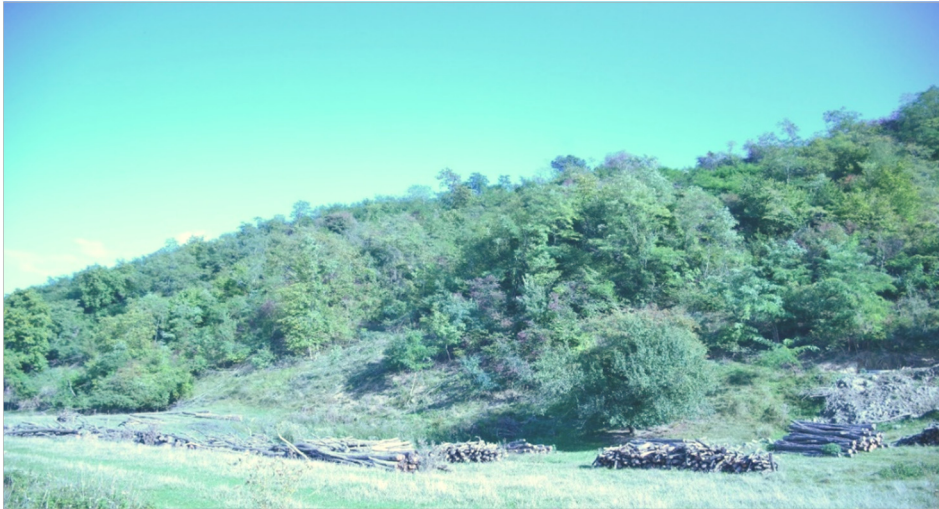
**Fig. 7.** The scarp of the landslide from Archiud, showing signs of deforestation

**The scarp** lies at approximately 500 m in a watershed region. It has a drop of sometimes 45-50 m. Its surface is affected by rain wash, gully erosion, and falls, processes that are amplified by massive deforestation on the hillside (fig. 7).

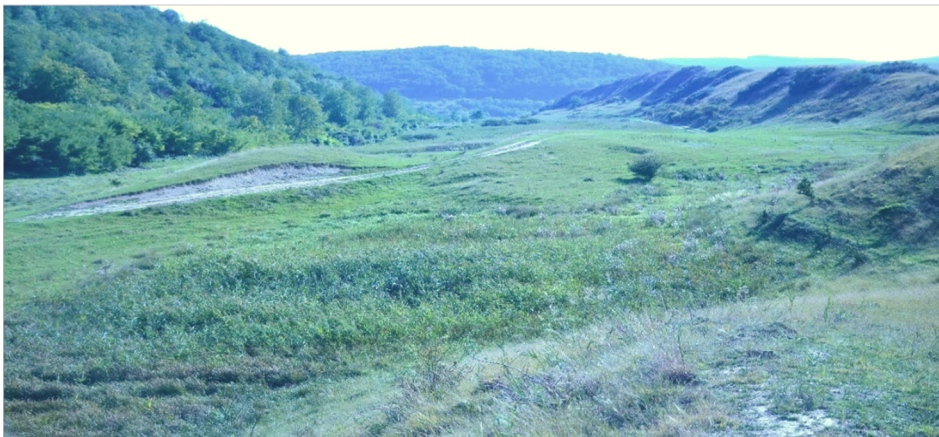
**Fig. 8.** Uniform hillock alignment and transversal depression

**The landslide mass** shows three rows of hillocks, extending parallel to the scarp and the transversal depressions. Their height drops from the scarp towards the front, with the highest being those from the last landslide alignment. The latter appears as a long range of about 1080 m and a drop of 10-12 m towards the depressions (fig. 8).

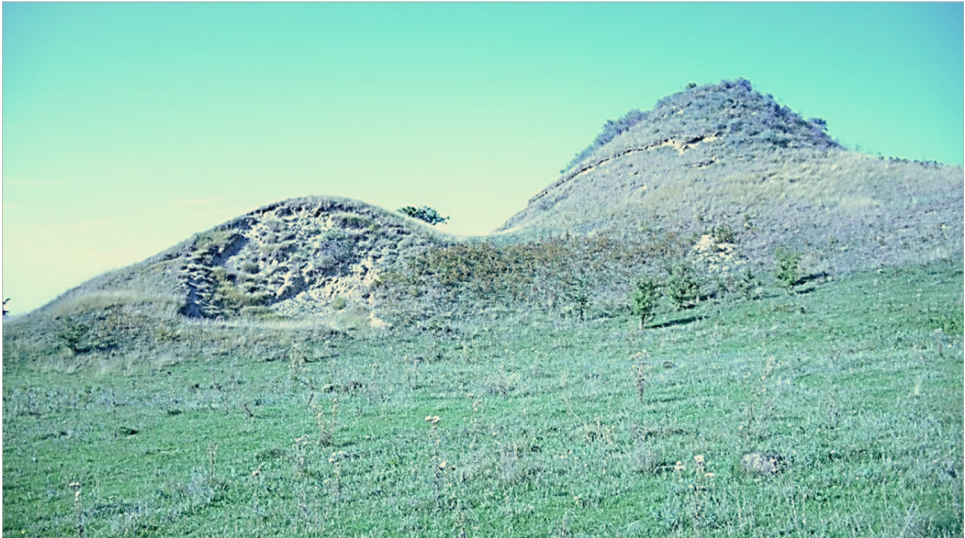
**Fig. 9.** Present-day erosion of the hillocks

The other rows are more fragmented and smaller, disappearing towards the front of the landslide. If the landslide as a whole is in a clear state of equilibrium, that is not the case of the hillocks, with dynamic morphological processes, such as falls, gully erosion, rain wash, and radial erosion, that are modelling these relief forms (fig. 9). Most hillocks are covered with grass and clusters of dog-rose (*Rosa canina*), blackthorn (*Prunus spinosa*), and sea-buckthorn (*Hippophae rhamnoides*), some of them showing on their southern slopes vineyards, nowadays mostly abandoned (Gârbacea, 2013).

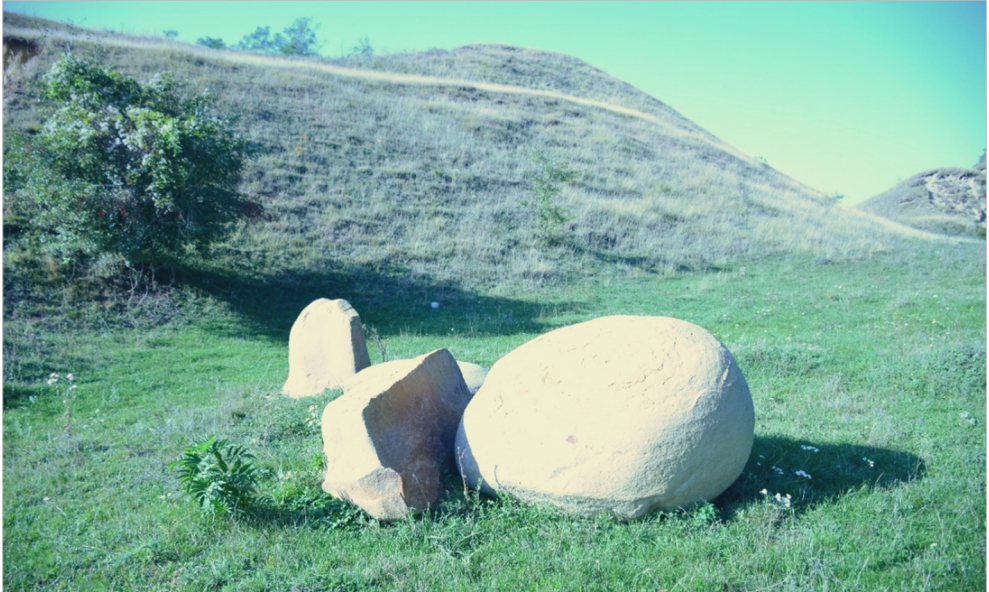
**Fig. 10.** Tortonian spheroid formations

Between the scarp and the hillocks there are the transversal depressions, the first of them situated between the last ridge and the scarp gradually increasing in width from 40 m at the east end to 95 m in the west, with a small incline from NE to SW. It is used as a pasture and at its contact with the hillock range there are spheroid Tortonian sarsen stones (fig. 10).

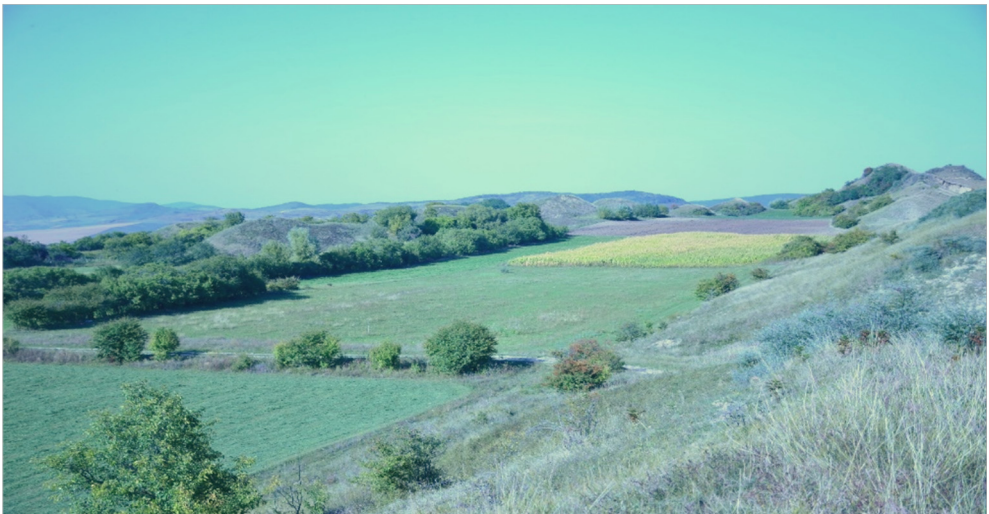
**Fig. 11.** Complex land use of the glimee-type landslide site

The width of the other depressions increases from 20-40 m in the east to 115-140 m in the west. A part of these depressions are cultivated with corn, wheat and alfalfa (*Medicago sativa*), some parts as hay meadows and pastures, while lower hillocks are used to grow fruits (mostly plume) and wine (fig. 11). At the west end of the site, the depressions are occupied by farms, that climb to the top of the hillocks. Due to their geological structure (clay, marl, and sands), some hillocks are used as source for building material (fig. 11).

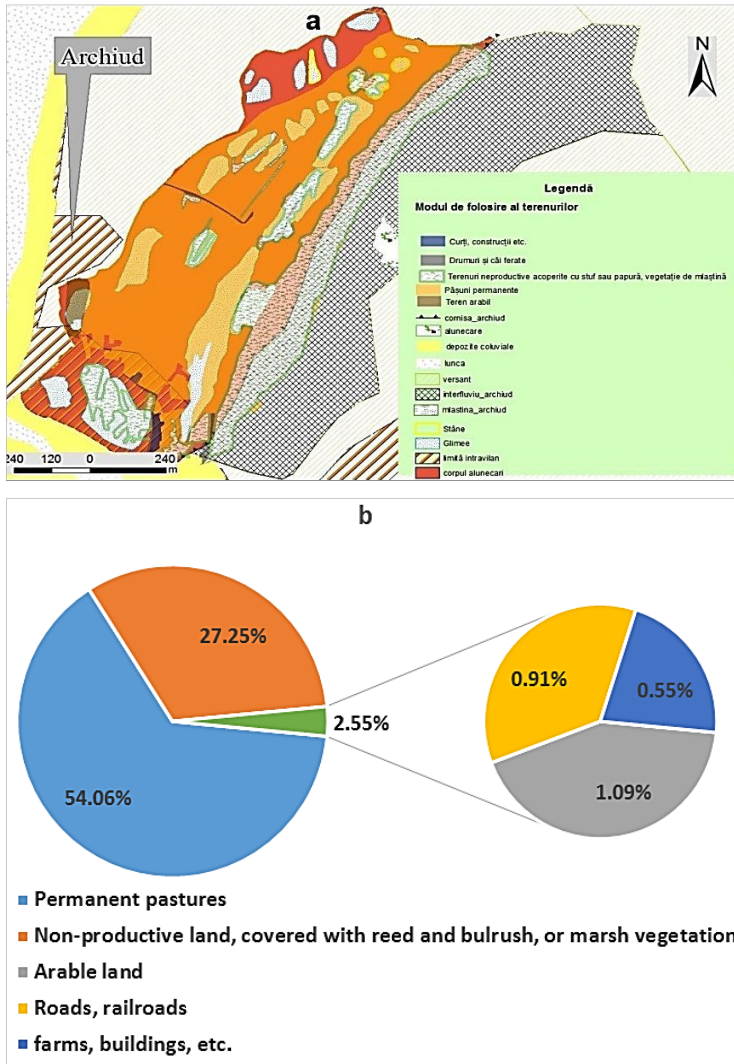
**Fig. 12.** Land use within the glimee-type landslide from Archiud, according to data from APIA, 2015 (a); agricultural reclamation rate in the site from Archiud (b)

Analysing the 1:5000 scaled topographical maps of the region we can learn that, prior to 1989, the most part of the site was used as pasture and hay meadow, a fact supported by the presence of three sheepfolds at the east end of the site, while the arable land extended in the vicinity of the village (fig. 12a).

At the present time (2015) the land use is showing signs of a return to its pre-1989 state, excepting the sheepfolds, due to population decrease and ageing in the village; high agricultural costs; and no viability of cultivating small land parcels. From the total area of 90 hectares, 54.06% are used as pastures, 27.5% are non-productive, 1.09% is arable land, 0.91% are roads, and 0.55% are covered by farms and buildings (fig. 12b).

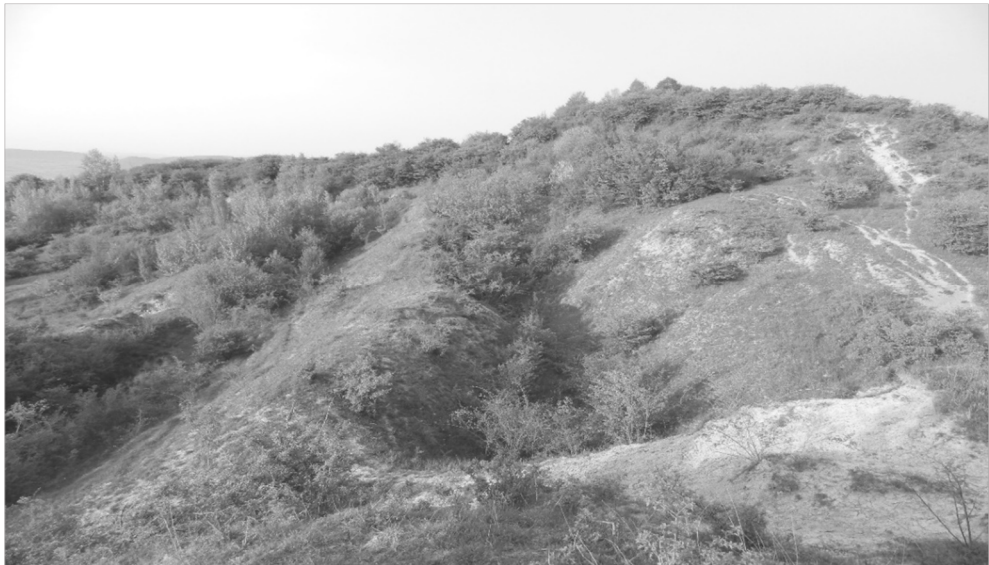
**Fig. 13.** The secondary scarp with hillock rows and transversal depressions

**The secondary scarp** is a 200 m long, L-shaped fault (fig. 13). On much of its surface, the stratification of the Tortonian deposits, with their northward incline, is visible. In longitudinal section, the watershed extends as a saddle between 382 and 380 m, respectively (fig. 14). This fact gives us reason to conclude that the landslide developed in two stages, the first giving birth to the hillocks in the first row, right behind the front of the landslide, while in the second stage, the hillocks beneath the secondary scarp were formed. During the second stage, a main scarp still existed, but is nowadays visible only as an anticline.

The transition from the secondary scarp to the hillock rows is made through a very narrow depression alignment (fig. 13), where traces of the existence of a small, now closed, pond are still visible. Its place is indicated by reed and the puddles that form during rainy periods. Compared to this alignment, the micro-depressions between the hillock ridges are deeper and larger.

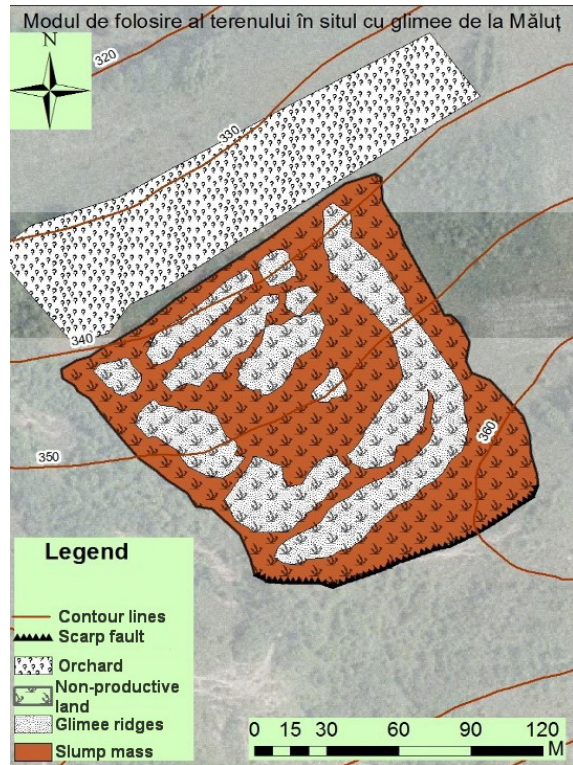
**Fig. 15.** Land use of the landslide from Măluţ, according to data from APIA, 2015

Regarding the land use in this landslide area, its entire surface is classified by APIA as non-productive land, covered with reed and bulrush, and only occasionally used as pasture (fig. 15). Analysing the 1:5000 scaled topographical maps, 1984 edition, it shows that in that period most of the landslide site was still non-productive, with pastures and orchards extending in its proximity.
