THE EFFECTS OF ACID MINE DRAINAGE UPON VEGETATION IN THE BOZANTA TAILINGS POND (MARAMUREȘ COUNTY)

The aim of the present research was: highlighting ARD phenomena (bacterial biocatalyzed) in the tailing on Bozanta pond terraces and the effects on vegetation.

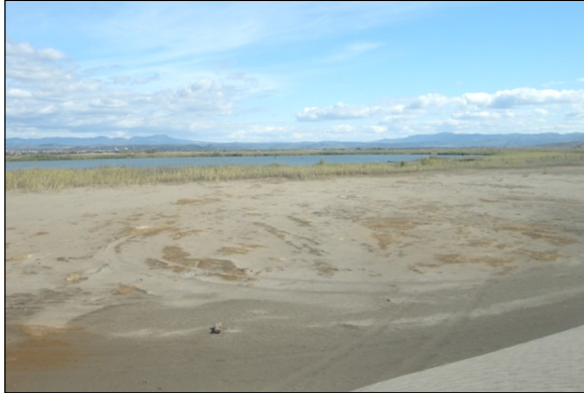
Fig. 2. *Tailings beach.*

Following the ceasing of activity in 2007, the mirror of the lake that covered the tailings retreated to the center, resulting in a huge area (figure 2).

In the absence of the mirror lake, the tailings from beach surface is subject to the process of acid rock drainage. Being a process that is performed in the presence of aerobic bacteria, the process is more active in the superficial layers:

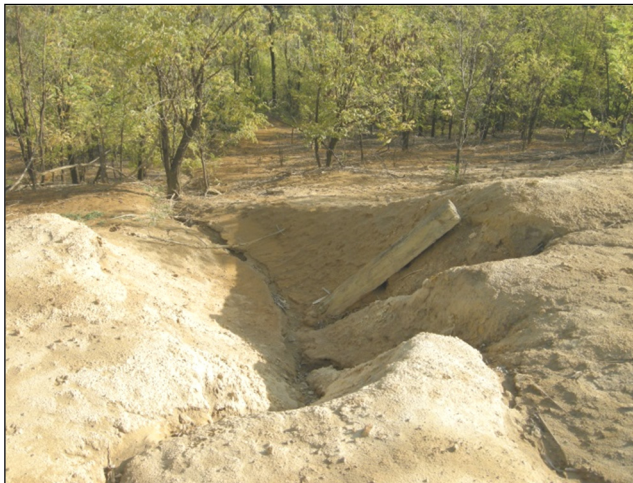
Fig. 3. Ravines on terraces T_3 .

On the upper terraces, T_3 and T_4 , where no vegetation planting or topsoil coating, ravines were formed, sometimes more than 150 cm deep (figure 3) and drifting tailings are common. On the basis of the terrace T_3 , strong exfiltrations can be noticed.

The yellow-red colour of the tailings, and also the presence of the reed clumps (*Phragmites communis*), plants which living in excessive humidity, is due to the presence of a high and permanent humidity on the surface of the tailings, due to some preferential exfiltrations of solutions from the lake in the middle of the pond to the surface of the terraces.

The phenomenon is a reason of concern because the exfiltration solutions in the lake start and maintain the processes of acid mine drainage in the terraces of the pond, causing damage in their stability, which can cause landslides of surfaces or dam breaking, unless appropriate measures are taken to fix the problem by draining the solutions in the pond.

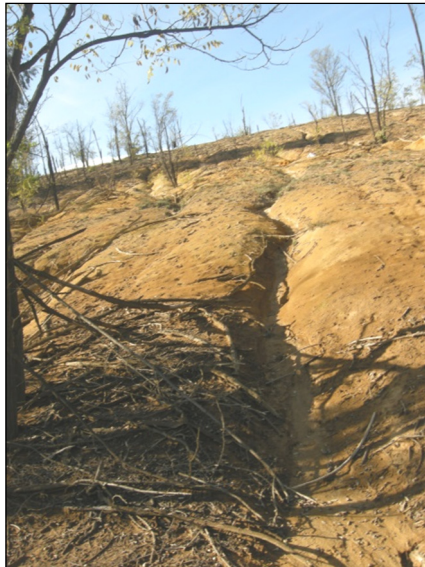
Fig. 4. Ravines on T₁ terrace.

On the surface of the terrace the runoff formed deep ravines from a few centimeters to 100 cm (figure 4), transporting tailings to the bottom of the pond, in the guard ditch, covering it. Here the reed grew in abundance, which prevents the collection and the disposal of the solutions. The solutions, acid and heavy metal, cross the auxiliary road around the pond, affecting the vegetation in the vicinity.

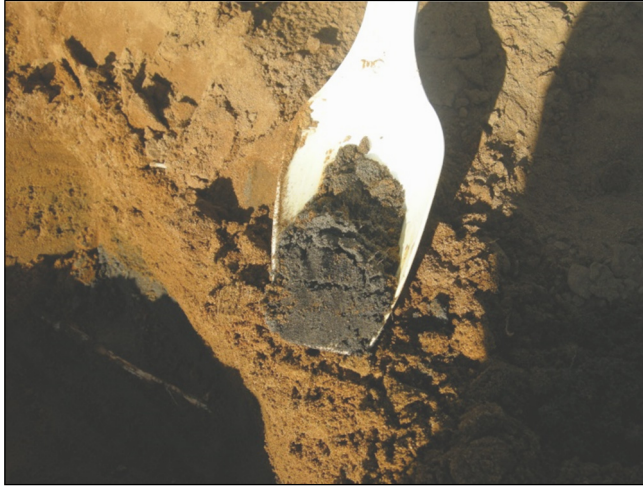
Fig. 5. *The layer of embankment dam of the belt (starter dike).*

Although the tailings are oxidized completely, and the solutions are very acid, the adult woody plants from the base of the terrace survive if some of the roots develop in the layer of embankment dam of the belt (starter dike) (figure 5).

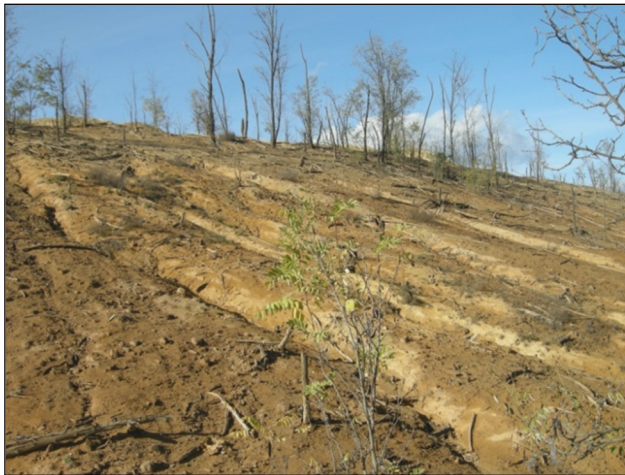
Fig. 6. *The ornamental acacia in T_2 terrace.*

On the terrace T_2 in the ornamental acacia trees area, the majority of the shrubs disappeared, resisting only a few specimens (figure 6). Also, the trees of acacia are almost dried totally. The drying of the green vegetation and of the trees on the upper terrace surfaces T_2 is the result of massive mobilization of tailings from the upper terraces T_3 and T_4 caused by wind and rain in the spring and fall.

The ravines have dimensions that reach 30-40 cm. The tailings are oxidized, reddish.

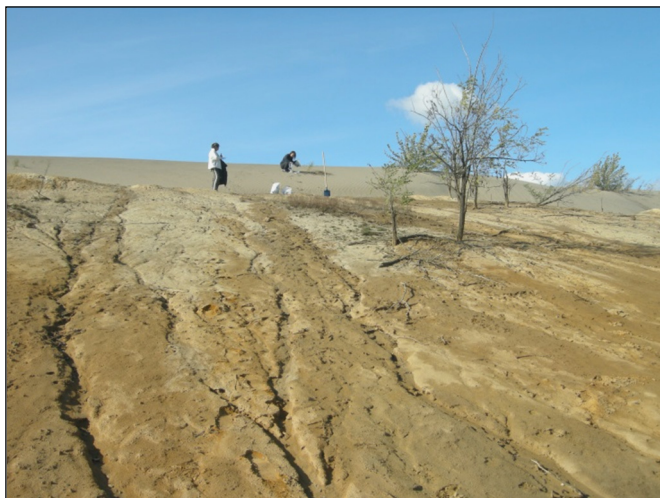
Fig. 7. T₃ terrace.

On the terrace T₃ where acacia trees were planted directly into the tailings dumps without the application of topsoil on the surface, the green vegetation is missing and the trees are mostly dry; the plants still living show obvious signs of drying branches and shoots (figure 7).

The tailings is oxidized and the superficial layer is always swept away by the wind or driven by the runoff waters.

On this terrace, numerous ravines are present, caused by rainwater runoff from the upper terrace. The erosion phenomena caused numerous landslides of the tailings, leading to its destruction of vegetation.
