THE IMPACT OF MINING ACTIVITIES ON THE WEST OF PETROȘANI DEPRESSION AND IDENTIFICATION OF AFFECTED GEOMORPHOLOGICAL RESOURCES. CASE STUDY: ANINOASA-VULCAN-LUPENI SECTOR

N. NIMARĂ¹, G. B. TOFAN²

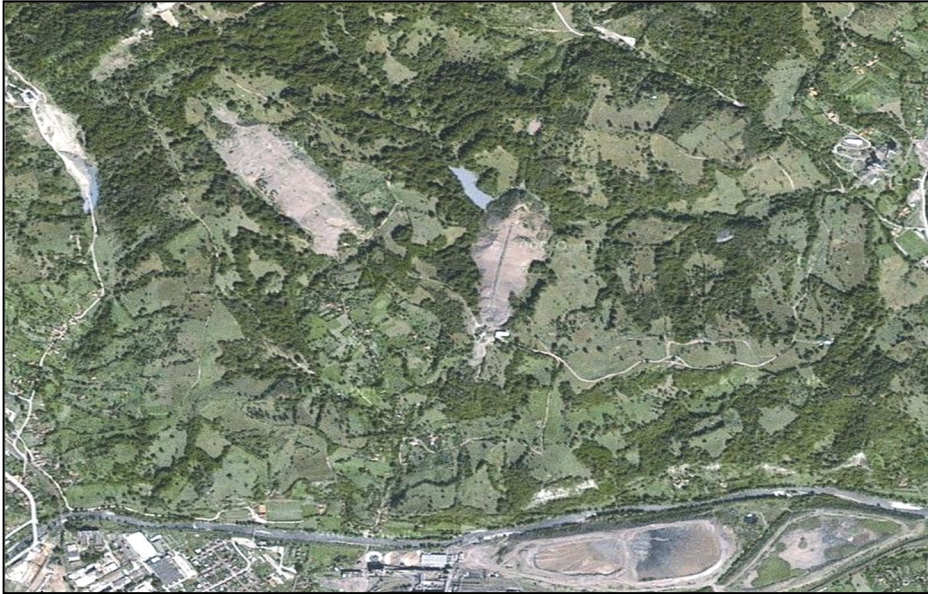
Fig. 1. Affected geomorphologic environment, in Vulcan perimeter (Căprișoara Valley).
(Source: <https://earth.google.com/>).

The deposit of slag and ash of Căprișoara Valley is located at 1.5 km from the power plant and covers an area of 45 hectares, consisting of two compartments. Deposition of slags and ashes is done in steps, consisting of cant executed successively in the various compartments of the deposit. The impact on the landscape is perceptible from a visual standpoint, being in disagreement with the natural environment, changing the original purpose of the land by the emergence of new landforms (fig. 1).

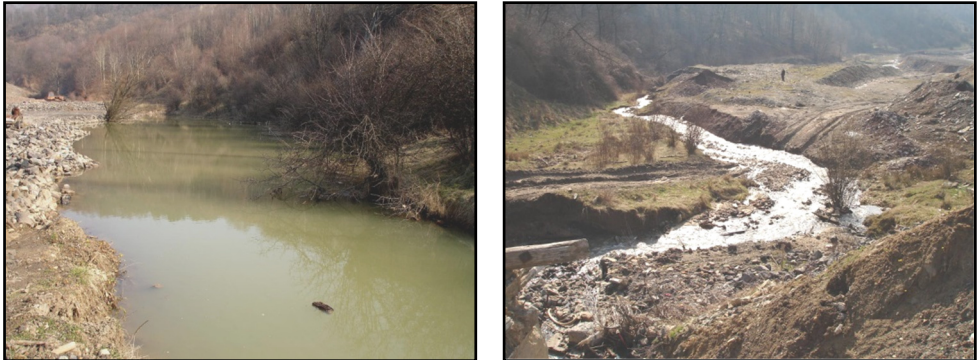
Fig. 2. The anthropogenic lake from Arsului Valley (a); The meadow of Arsului brook (b).
(Source: C. Nimară, 2011).

In hydrographic terms, the dump area and the adjacent areas are affected by Arsului Valley brook and gullies that formed on the slopes during heavy rainfall. After dumping in the valley, the stream has diverted its riverbed and downstream a lake has been formed due to land sinking by the underground mining activity, with natural drainage possibilities (fig. 2a).

The presence of the lake, formed locally, is an unfavorable factor in terms of stability, as water saturates the rocks at the bottom of the heap and modifies the physical and mechanical properties of the land base.

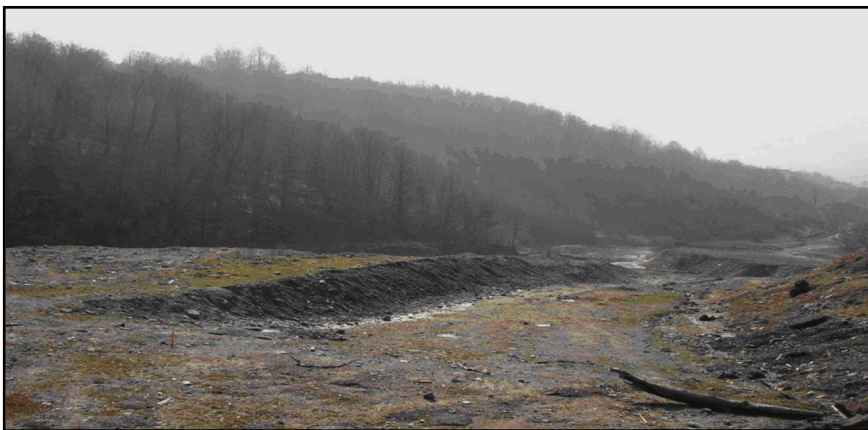
Fig. 3. Clough formed in the central part of the sterile dump.
(Source: C. Nimară, 2011).

In the middle of the dump there is now a central clough running through its central body in the NE - SW direction (fig. 3) (C. Nimară, 2011).

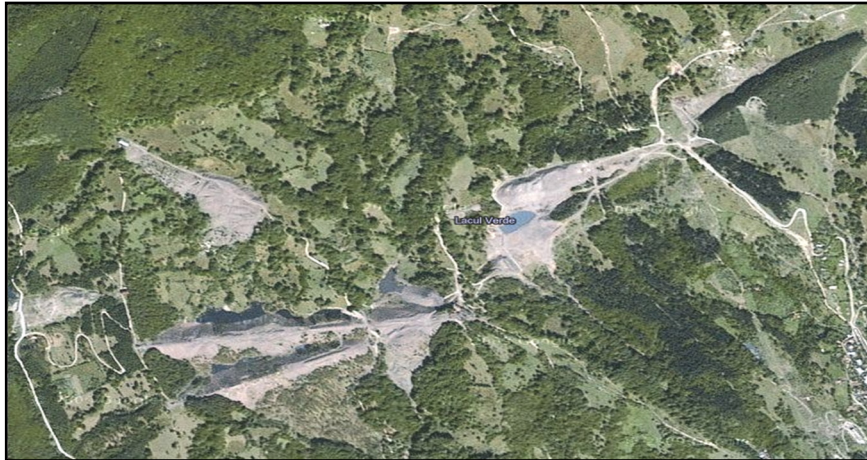
Fig. 4. The anthropogenic impact on the relief in the Ferejele valley-Boncii brook perimeter.
(Source: <https://earth.google.com/>).

This landform is affected by the sterile dump of Lupeni coal preparation factory (fig. 4), being surrounded by the hills: Dâlma, Boncii and Renghii (the slopes are between 6° and 35°).

The slope of the dump is about 9°. Because of these angles and due to the presence of water runoff during periods of heavy rainfall, erosion and some slip phenomena are present. The form of the dump on all three sides is not uniform and the material deposited on the dump consists of sandstone rocks, clay, marl, shale and carbonaceous sandstone. In the area of the waste material, cones can be seen, which are then leveled by a loader so that ultimately leveling platforms are formed.

Shallow formations represented by topsoil and hillside covering the area are sometimes eroded and basic rocks in outcrops occur. There are landslides on the southern slope in the area of P4 and P5 pillars, accompanied by repressions of the land base. This landslide that extends over 170 m in the present is stabilized by placing the rocks of the group of sliding at an angle of slope of 24°-25°. After waste materials were dumped in the perimeter of the two valleys, the stream riverbeds have been diverted and upstream several lakes were formed without natural drainage possibilities.

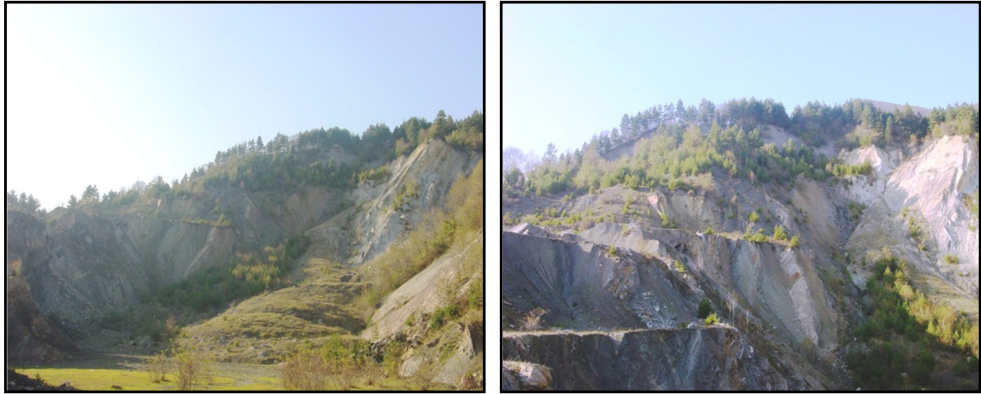
Fig. 5. Victoria coal pit and the landslides on its slopes.
(Source: Nimară, 2011).

The total surface area that corresponds to Victoria coal pit is 200,682.6 m², which is totally degraded. On the other hand, the northern slope of the coal pit is affected by landslides due to rainfall.

Generally in areas with rugged terrain, as in the area where Victoria coal pit is located, breaking the static equilibrium where there is a rock deposit is caused by shear forces that alter the internal cohesion of the particles constituting the rocks in a field gravitationally active as a side can initiate land mass displacements (fig. 5) (R. U. Cooke, J. C. Doomkamp, 1990; I. Rotunjanu, 2005).

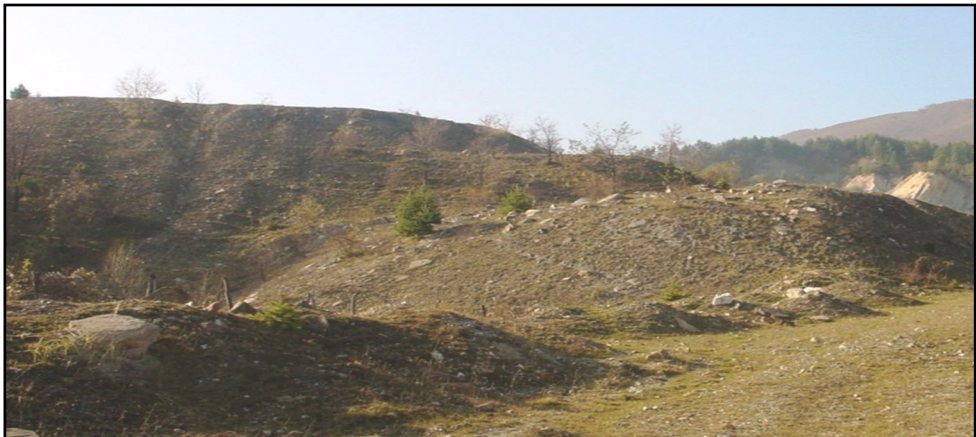
Fig. 6. Sterile dump, Victoria coal pit.
(Source: Nimară, 2011)

The sterile dump of Victoria coal pit is in conservation. Structurally, the dump is made of clay covering an area of 3.18 hectares and has a volume of 2,875,272 m³ (fig. 6).

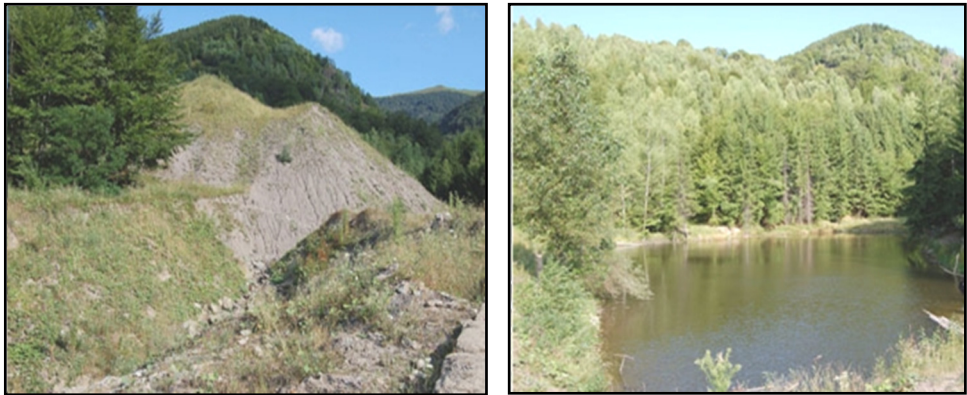
Fig. 7. The sterile dump from the left slope (a); The lake formed at Mierlașului Valley (b).
(Source: Nimară, 2011)

The sterile dump from Bărbăteni mine is located on the southern slope of Mierlașu Valley (Mierlesei Valley on some maps, fig. 7 a). This form of anthropogenic accumulation is located about 2 km away from Lupeni and arose from mining excavation processes of EM Bărbăteni.

In terms of grain size, the sterile dump consists of rock fragments with similar particle size fractions of gravel and boulders, covered in a mass of yellow-gray clay.

Rainfall that have a high frequency in April-May and September-October, given the physical and mechanical properties of the rocks present in the constitution of this form of accumulation (clay, marl, sandstone, shale coal), led to the launch of mass displacement processes, after which there was a partial crossing of the brook and the formation of a reservoir upstream of the dump body at the western end. The bottom of the lake is situated at an altitude of 867 m and has an almost oval shape (fig. 7 b).
